Technology, MEET Constructability

The second installment of the “But It Worked in the Model!” series serves as a cautionary tale about the overdependence on technology and the underestimation of constructability factors.

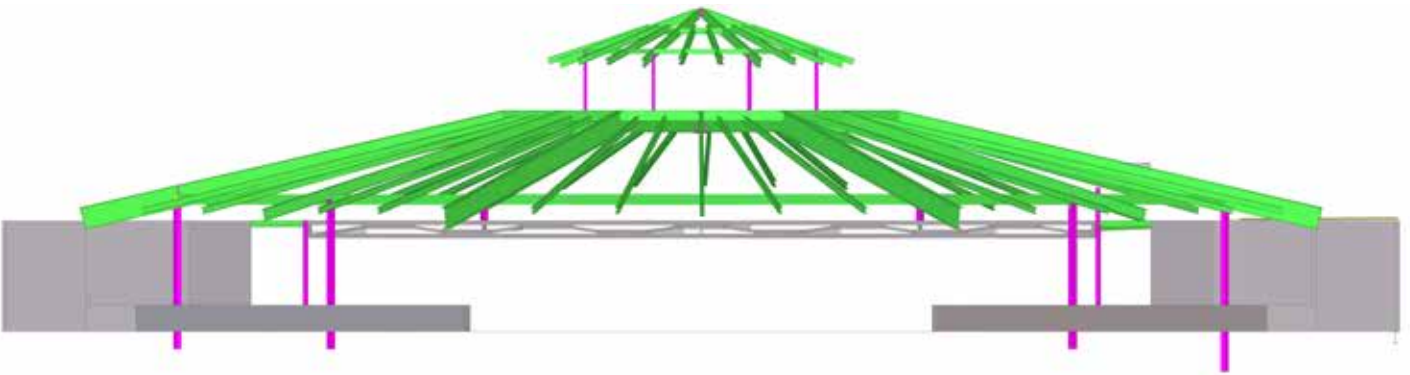
▲ Figure 3. The tension ring after initial failure.

With the majority of the structural steel in place, the roof joists installed and installation of the metal deck on the flat roof portion of the structure nearing completion, a sudden breach of the dome tension ring precipitated a partial collapse of the structure (Figure 3). At the time of the collapse, the majority of the flat roof and dome structural elements were in position but not fully connected. Tension ring members were tack-welded in position, ties to the supporting shear walls were incomplete or nonexistent and the lateral-load-resisting flat roof diaphragm was not attached to the exterior shear walls. Thus, the lateral-load-resisting system did not exist. The owner and the contractors were perplexed, and in this case the structural engineer of record's response was, "But it worked in the model!"

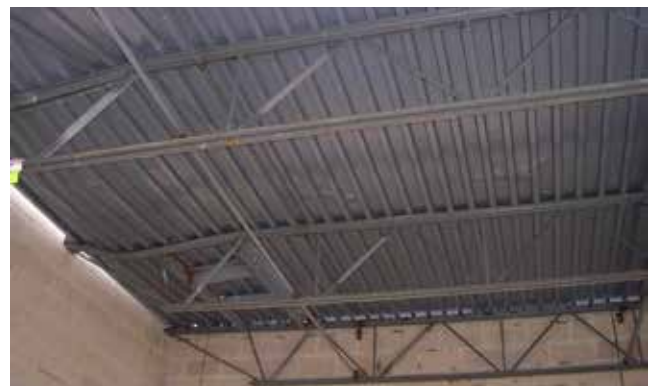
The photograph of the as-built connection after the collapse shows a separation between the wall and the roof deck (Figure 6b). This design detail was not included in the metal deck or structural steel installation drawings as submitted by the fabricator.

▼ Figure 6b. Separation between wall and roof deck.

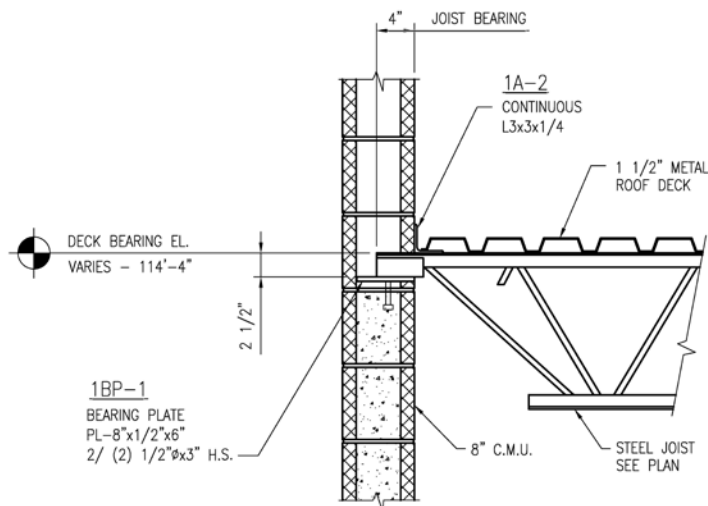
▲ Figure 7a. Detail from the erection drawing.

Similarly, the detail (Figure 7a) depicts a continuous angle spanning the length of the wall connecting the roof deck to the shear wall and effectively completing the diaphragm. Once again, the photograph (Figure 7b) displays the absence of any such connection, as light can be seen pouring through the gap between the deck and wall. Though each case admittedly displays a lack of quality control and poor construction practice, an overriding concern is the lack of a thorough shop drawing approval by the structural engineer and an apparent disregard for the importance of the metal deck connection in effectively distributing the lateral load to the shear walls.

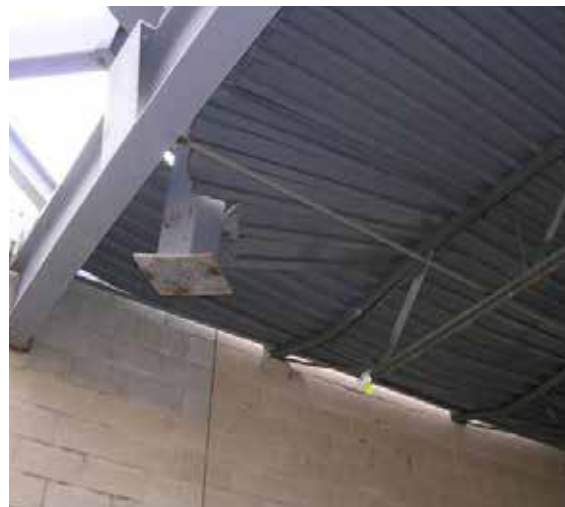
▲ Figure 7b. As-built construction.

In addition, note the stub in Figure 7b, which shows a support post for the dome roof structure that translated during the collapse. The dome rested on short posts without any provision for lateral load transfer to the metal deck diaphragm or subsequently to the reinforced masonry shear walls. All the components were there in some fashion, but the interdependence on the structural steel and nonstructural steel elements were totally undefined in the contract documents and therefore did not become an integral part of the installation documents.
