# BEYOND Limits

The fourth installment of the “But It Worked in the Model!” series takes a look at a project that illustrates the limitations of computer-aided design and analysis.

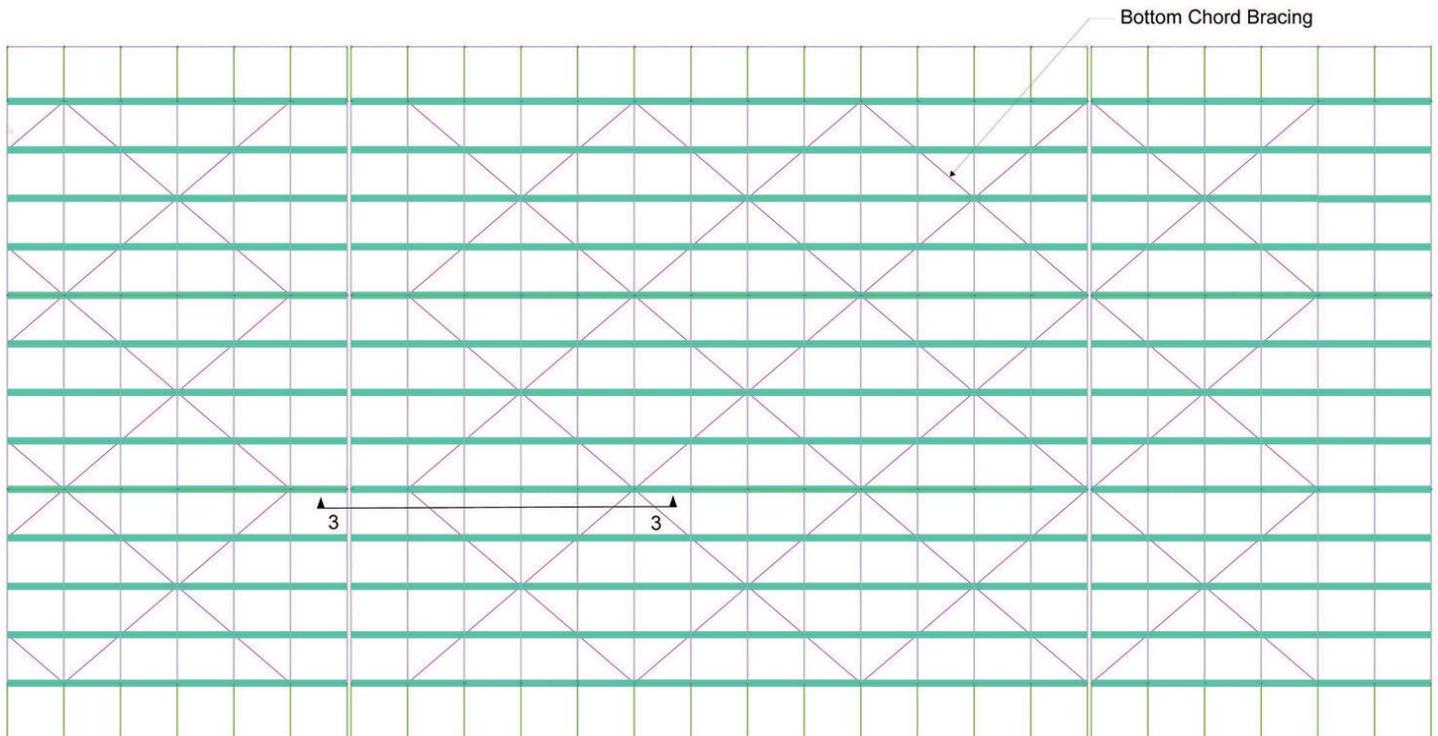
In looking at the sample industrial project’s framing plans (Figures 1 and 2) we see a relatively simple braced framing system for a manufacturing facility. The design focuses on minimum weight: a roof system consists of open-web steel joists supported by roof trusses, with bottom chord X-bracing and a longitudinal vertical bracing scheme on the column lines.

▲ Figure 1. A partial plan view of an industrial building with horizontal bracing at the bottom chord.

Of particular interest here is the structure’s lateral load resisting system. As modeled, a lateral load parallel to the roof truss would be resisted by the roof truss/column frame. This in turn is stabilized by the roof framing: an open-web steel joist and roof deck diaphragm. For lateral loads perpendicular to the roof truss, the roof deck diaphragm distributes the lateral load to a single open-web joist framed between columns. The columns transmit the lateral force in bending to the longitudinal vertical X-bracing (Figure 3, page 46). The horizontal bottom chord X-bracing spans the entirety of the bay but only stabilizes the roof truss bottom chord since there are no sway frames. Thus, this structure, which at first glance

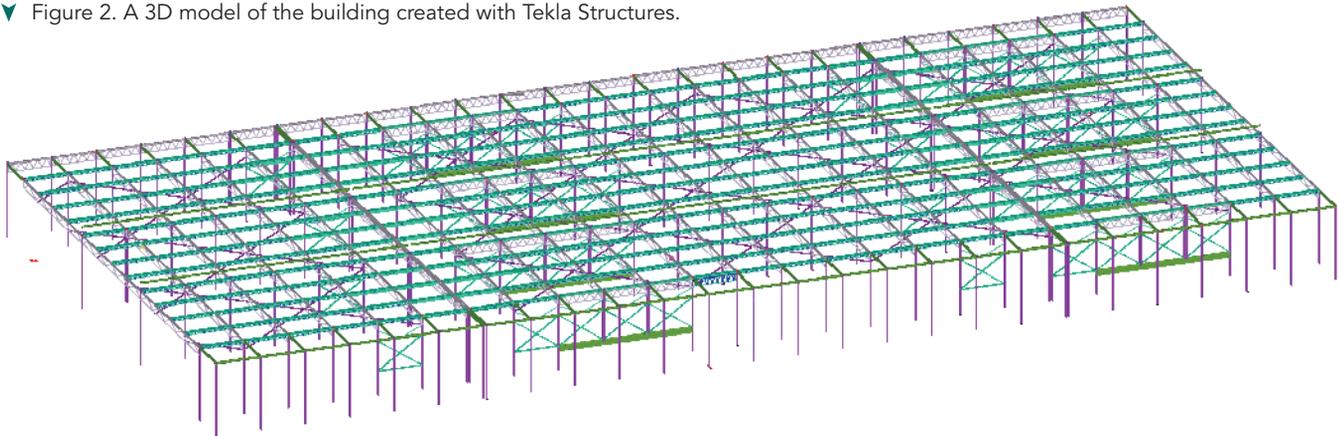
▼ Figure 2. A 3D model of the building created with Tekla Structures.

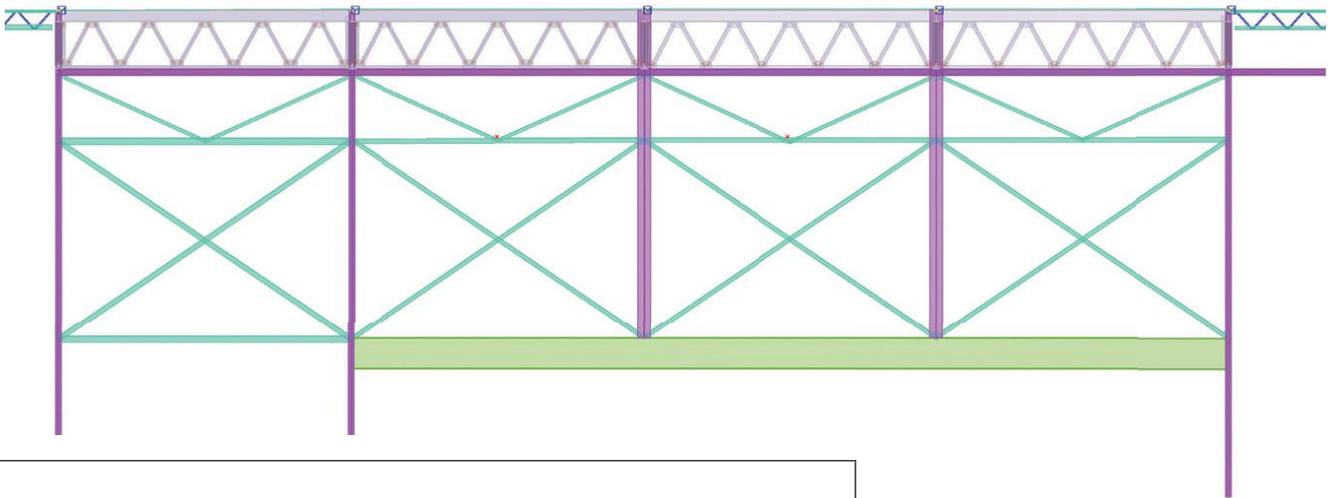
Stability for lightweight design concepts is often an issue, but something makes this particular facility unique: a tension-only bracing scheme, both vertical and horizontal. The tension-only scheme consists of vertical X-bracing located on the column lines near the ends or expansion joints of the building and horizontal bottom chord X-bracing. Tension-only struts connect the vertical and horizontal braced bays. This brac-

▲ Figure 3. Typical longitudinal vertical bracing.

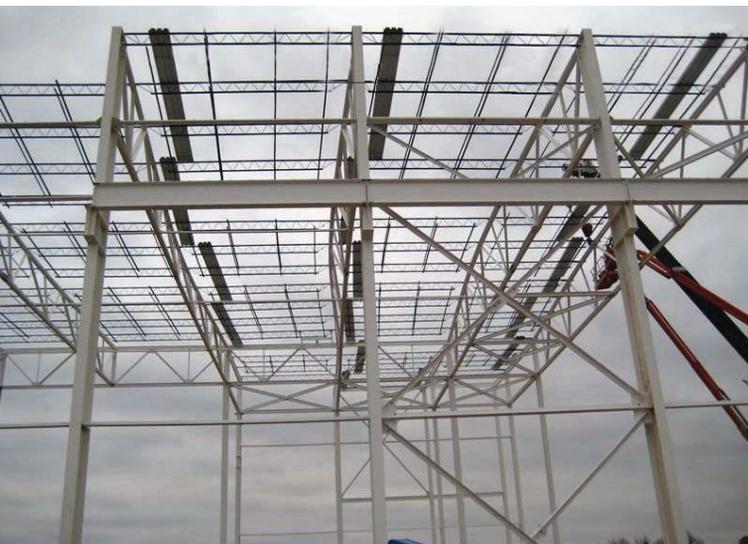
▲ Figure 5. A temporary tension bracing scheme for the building.

It is important to note that the industrial structure in this case was salvaged by developing an engineered erection plan after constructability issues became apparent. The engineered erection plan focused on the stabilization of the roof trusses, the open-web steel joist and the supporting columns. A temporary tension bracing scheme (Figure 5) was introduced to brace the main column lines and maintain tension in the steel joist. Temporary sway frames and top chord cable bracing were necessary to reduce the unbraced length of the roof truss top chords. Additional horizontal open-web steel joist cable X-bracing provided a load path for lateral load distribution. The temporary tension bracing on the column lines was preloaded to maintain a tension load in the open-web steel joist framing, column to column. This tension bracing scheme was necessary due to the minimal compression capacity of the joist framing between the columns, which precluded the use of typical cable X-bracing. The temporary tension bracing was leapfrogged every fourth bay, as were the joist girder temporary bracing and sway frames. This approach provided temporary longitudinal and transverse stability. The temporary tension bracing was necessary until the key elements of the structure's lateral load resisting system were installed, including the tension-only bracing and roof deck diaphragm.

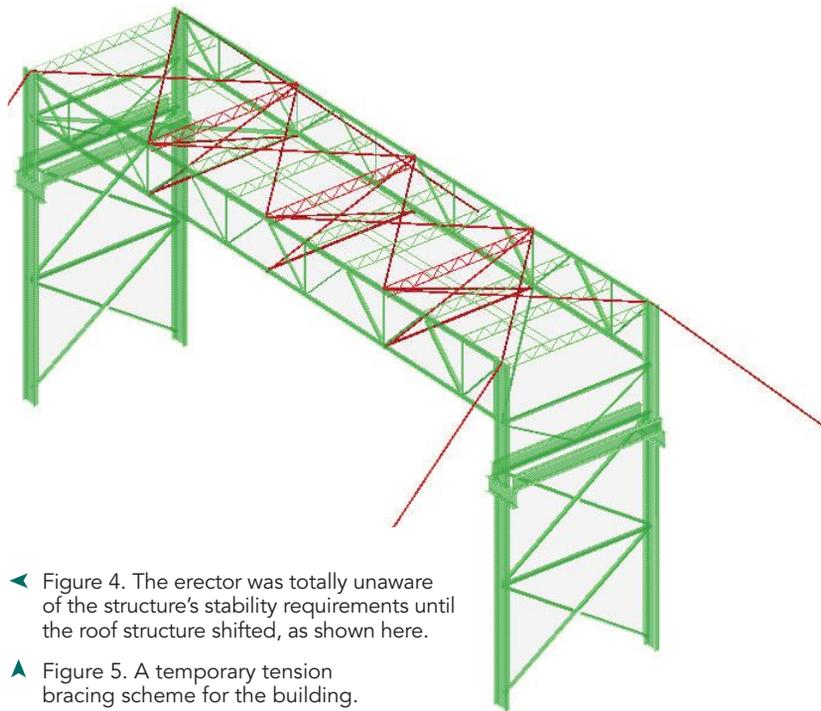
In this case, the erector was totally unaware of the structure's stability requirements until the roof structure shifted, as shown in Figure 4. The first four bays were in distress but did not collapse. To the erector's surprise, this industrial structure, which would not normally require any significant temporary bracing, required an extensive temporary bracing system to maintain stability until tension-only elements were properly installed and the roof deck was complete.

◀ Figure 4. The erector was totally unaware of the structure's stability requirements until the roof structure shifted, as shown here.

For this project, the structural engineer neglected to provide the information required by Section 3.1.4 and Section 7.10.1 of the AISC Code. The engineer did not define the lateral load resisting system, its dependence on the non-structural steel elements (open-web joists, joist girders and metal deck are not considered to be structural steel per Section 2.2 of the Code) and the connecting diaphragm elements. In addition, the structural engineer did not indicate the unique design concept: a tension-only lateral bracing scheme. The erector proceeded to erect the initial four bays conventionally such that the framing was in place prior to the installation of the metal decking. The partially erected system became unstable, devoid of a diaphragm and vulnerable to wind and construction loads. Lacking sway frames and left temporarily unbraced, the top chord of the joist girders bowed due to the loads induced by gravity. The intended load path, reliant on the presence of the roof deck, was critically disrupted. As evident by the visible lateral movement of the system, the structure was unstable and in danger of collapse if not im-
